LA-UR-17-28647

Title: Effects of Laser Etching on the Corrosion Susceptibility of SAVY 4000
and Hagan Containers

Effects of Laser Etching on the Corrosion Susceptibility of SAVY 4000 and Hagan Containers

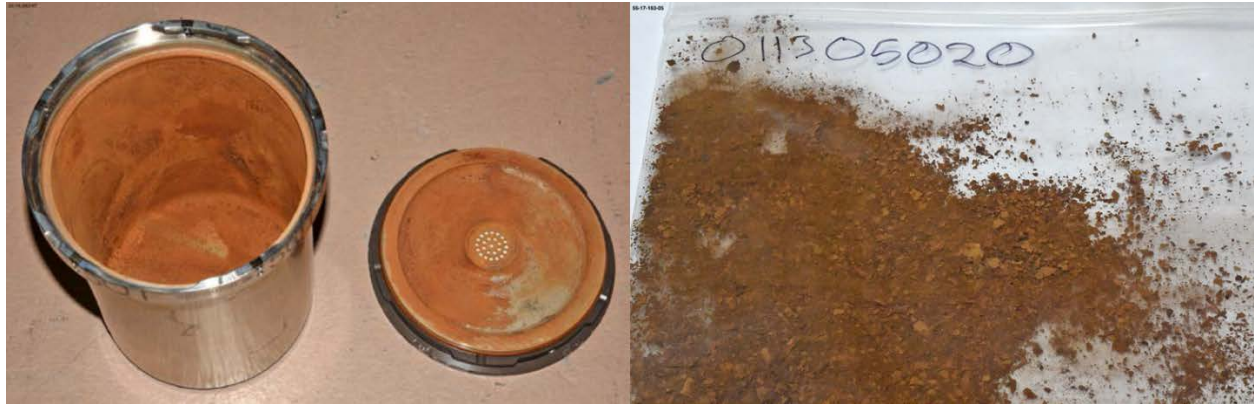
Figure 1: SAI SAVY 4000 after 14 months exposed to HCl vapors. Red corrosion product was all over walls of container.

During recent surveillance activities, two SAVY 4000's containing Solution Assay Instrument (SAI) solutions were opened. The SAI SAVY 4000's contained plutonium (Pu) in 3M HCl solution in plastic volumetric flasks placed inside of polyethylene bags. Historically, a SAVY 4000 containing an SAI solution is packaged for 3 weeks, however, these particular containers were not reopened until 14 months later. When opened, brown-red corrosion product was found all over the inside of the container as shown in Figure 1.

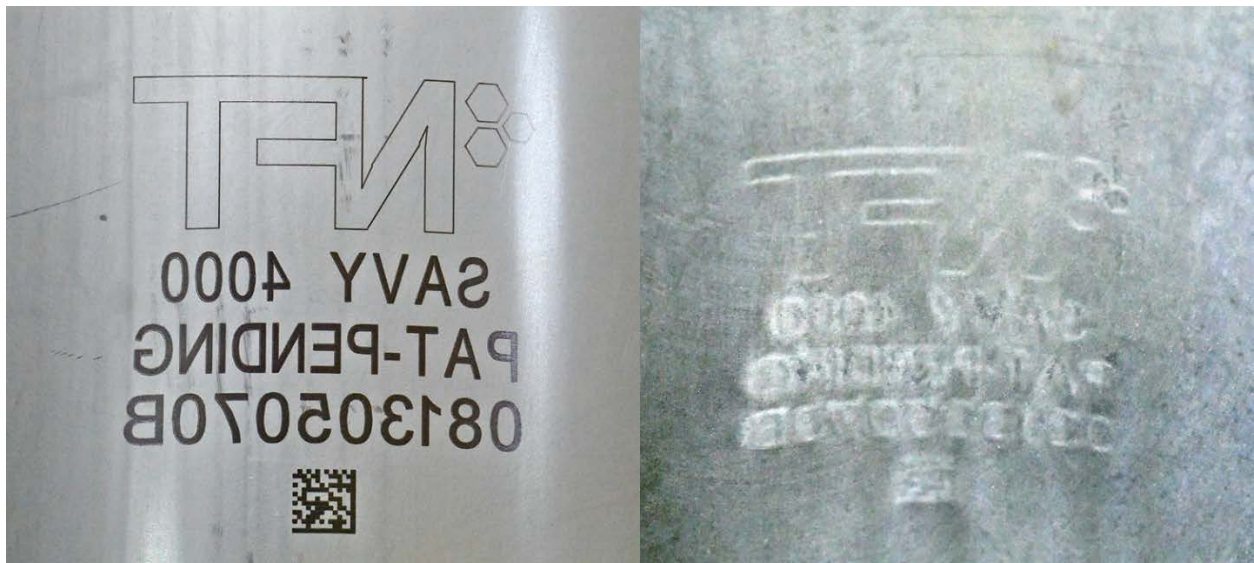
Besides the corrosion product, the most perplexing feature was that the laser etching on the outside of the container to mark the tracking number and QR code had shown through to the inside as shown in Figure 2. The laser etching cannot be seen on the inside of pristine SAVY 4000 container.

Figure 2: The NFT SAVY 4000 logo printed on the outside of the containers (left) and the same logo seen on the inside of the container after being exposed to HCl vapors for 14 months (right).

The image on the inside of the container is the heat affected zone (HAZ) that is produced from the heat of the laser when contacted with the container. The HCl may have chemically etched the interior removing all oxide layers and leaving the surface unprotected to chloride attack [4]. The etched area has never been thought to be a potential problem until this observation.

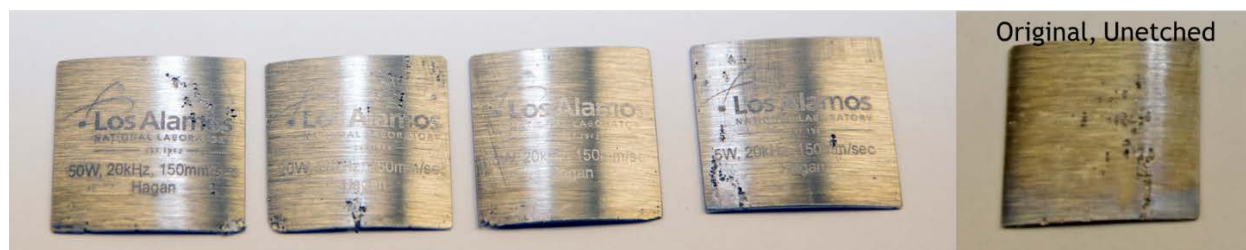
Figure 6: Hagan pieces after being in FeCl_3 solution for four days. First four are replicated with varying power -- 50, 20, 10, and 5 W -- 20 kHz and 150 mm/sec. Fifth piece is of the original unetched Hagan.

Figures 5 and 6 are photographs of the set 2 pieces after they were subjected to FeCl_3 . There are many areas where the FeCl_3 ate away at SS. These areas are responsible for the larger amount of mass loss. Affected areas may not have been seen in set 1 as the FeCl_3 was disrupted by the disintegrated binder clips. Moreover, the binder clips were used to help reduce crevice corrosion. Crevice corrosion is a phenomenon in which a crevice is made (typically submicron to ~ 2 mm) with a corrosively active material causing build ups of acidic ions such as H^+ and Cl^- [4]. The acidic ions then eat away causing pits and corrosion products [4]. The eaten away areas of set 2 were more along the edges where the SS was in contact with the glass where a crevice may have been made causing crevice corrosion.

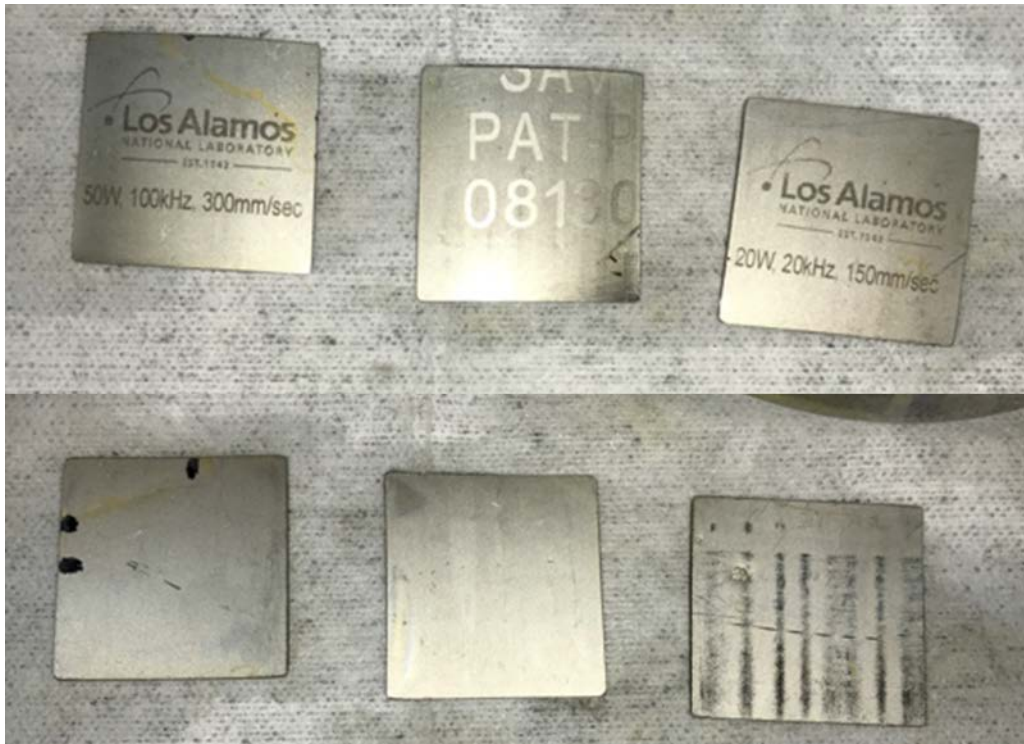
Figure 7 shows three SAVY 4000 pieces that were imaged with the DIC-CM before being exposed to FeCl_3 for 72 hours. Table 5 shows dimensional and weight analysis of the pieces both before and after being exposed to FeCl_3 . Dimensional analysis was only performed on the pieces being analyzed under the DIC-CM as calipers used were not sensitive enough to really reflect any changes in the dimensions. Weight changes were recorded and were minimal. These samples were corroded in the same solution as set 1.

Figure 7: Three samples imaged with the DIC-CM. Left to right: Max, original SAVY 4000, and replica of original SAVY 4000 parameters. Photos taken after 24 hours in FeCl_3 .
